# **CSIRO** ACOUSTIC MEASUREMENT REPORT

Commonwealth Scientific and Industrial Research Organisation, Infrastructure Technologies Acoustics Testing Laboratory, Gate 5, 2 Normanby Road, Clayton, Vic 3168 Australia Report No: TL665-07-1

### Measurement Type: Airborne Sound Insulation

Designation: Jolong 70 Series alu thermal break inward opening hinged door;

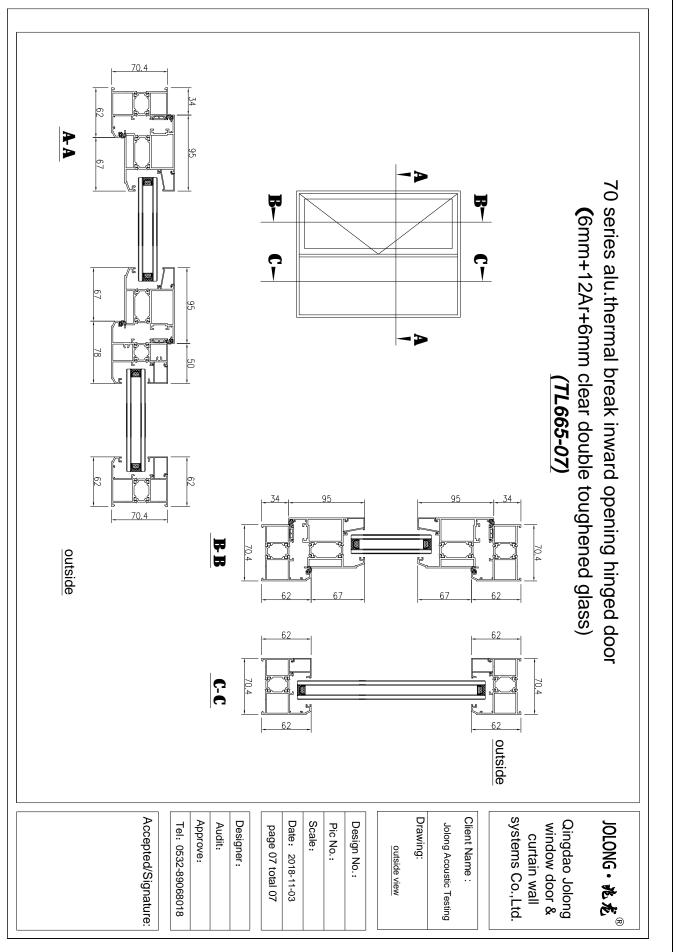
Additional Test Specimen Details (from drawing provided by client)

- As per client drawing 'Jolong Acoustic Testing(Detail drawing).pdf', page 7.
- Hinged door (opening to internal side of test specimen), alongside fixed unit.
- Framing: proprietary aluminium extrusions.
- Glazing: double glazed system, 6 mm clear toughened / 12 mm Argon / 6 mm clear toughened.
- Mechanical components: door wheels, handle, triple-point lock etc as per Jolong specifications.
  Sealing: as per drawing, rubber glazing wedges sealing glazing units in sashes, sashes sealed to frame with linear sealing components fitted into extrusion profiles and/or adhered as per design, and overall frame sealed within test aperture of laboratory using wet caulking. Dry sealing was supplemented with wet caulking where necessary, but not in places where the operability of the door would have been affected.

#### See following page for client drawing.
